Report on excavations at the imperial vicus 1995-1998*

by Amanda Claridge

The purpose of the excavations

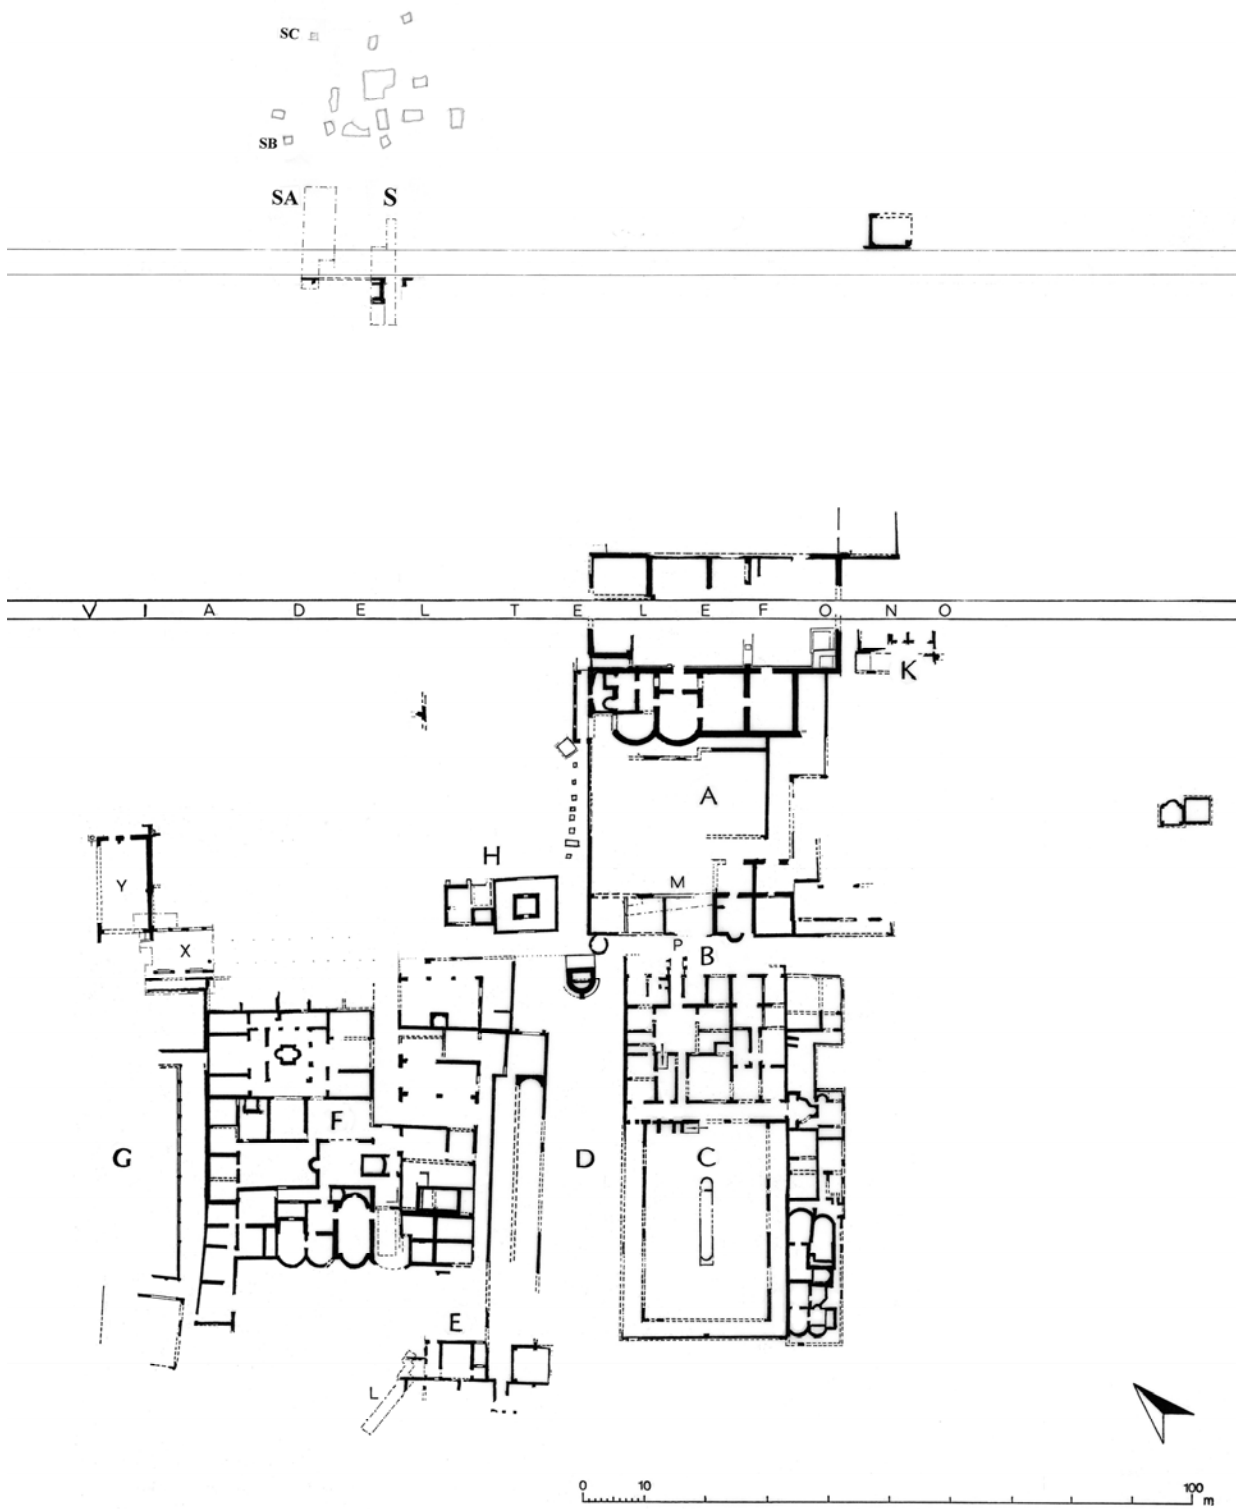
Fig. 1. Vicus Augustanus (Castelporziano). General site plan showing locations of trenches X and SA

Following upon the completion of the surface survey and analysis of the structures exposed by the excavations of 1875-1912 (circa), two new excavations were undertaken in 1995-8, in the form of trenches X and SA (see general site plan Fig.1).

Trench SA on the other hand was intended to produce a substantial sample of the ancient rubbish dumps on the inland side of the via Severiana, first identified in 1984-86 (see Fig.1 and *Castelporziano I*, p. 72; *Castelporziano II*, p.70). As well as providing general evidence for the economic status of the town, it was hoped that the sample would also be of value for eventual

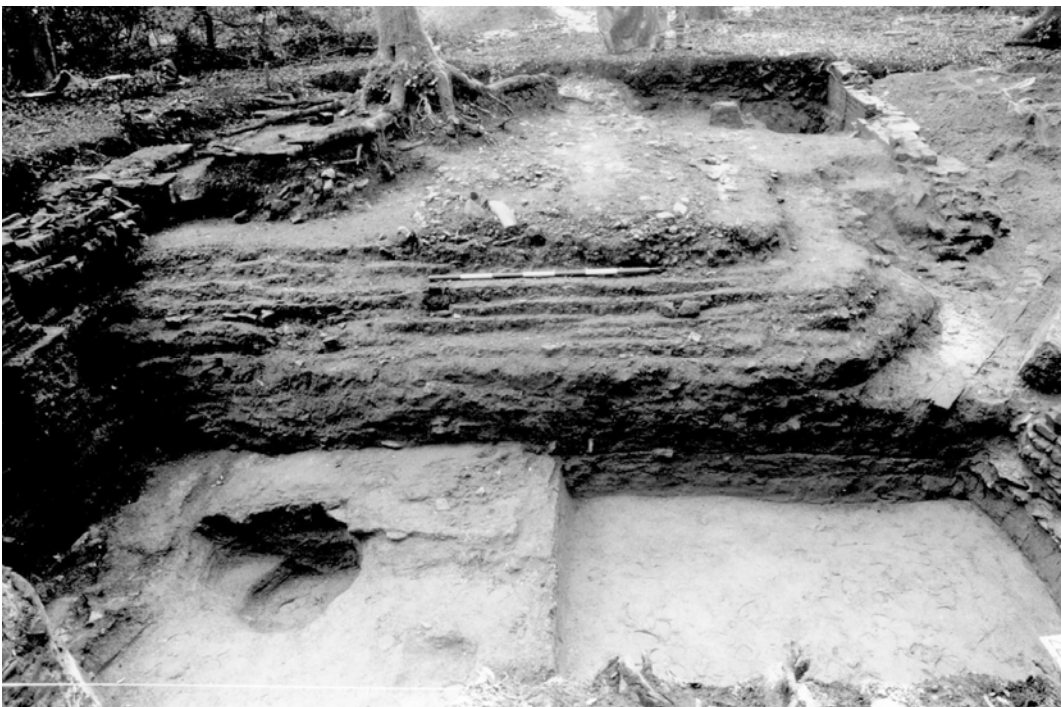
Fig. 3. Vicus Augustanus. Trench X. Final state, from west

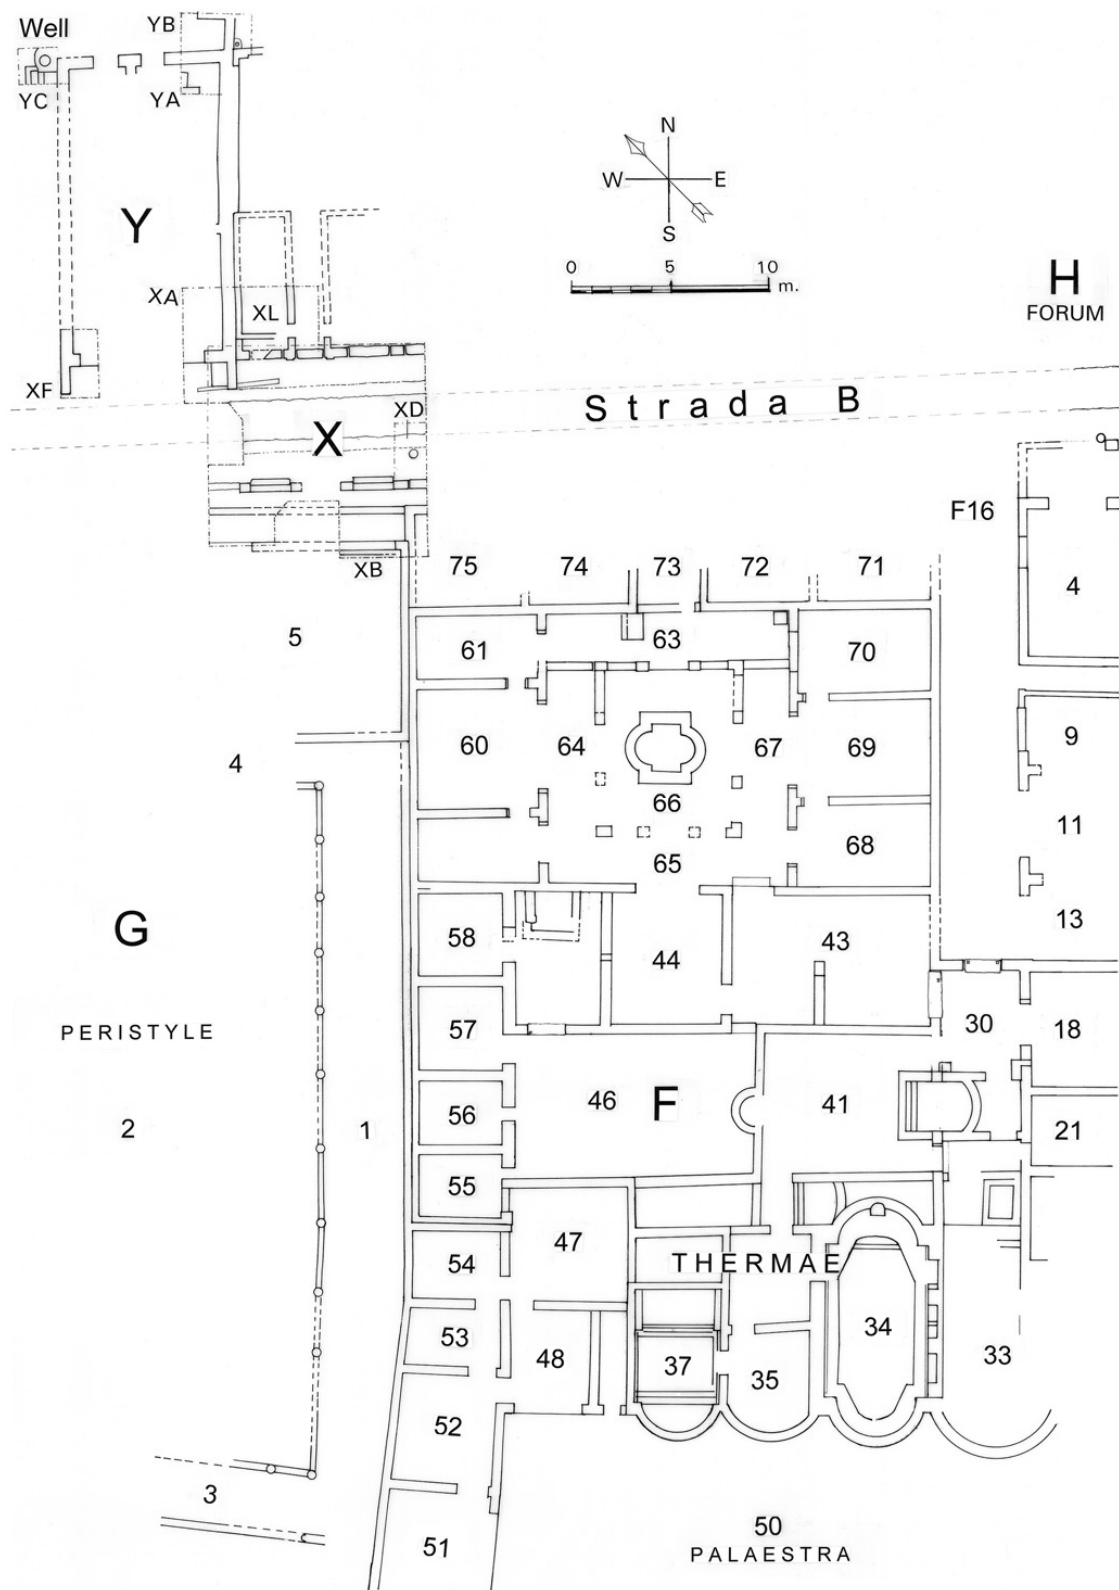
Fig. 4 Vicus Site plan Zones F-G with location of trench X and building Y

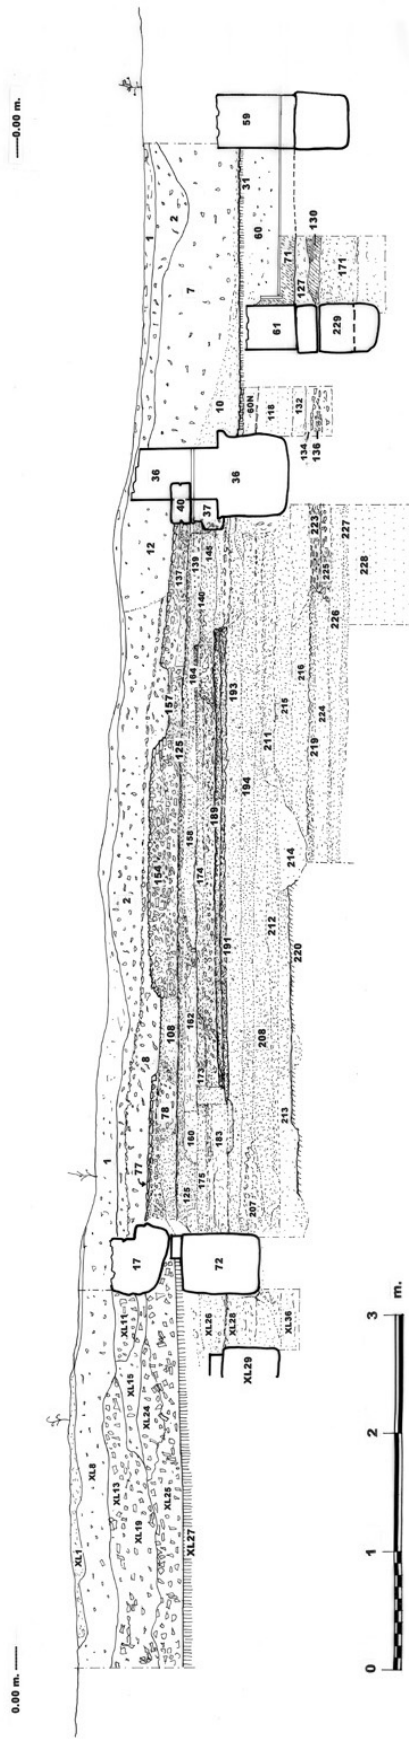
Fig. 5. Vicus. Trench X. N-S section across street B and buildings to either side, looking east

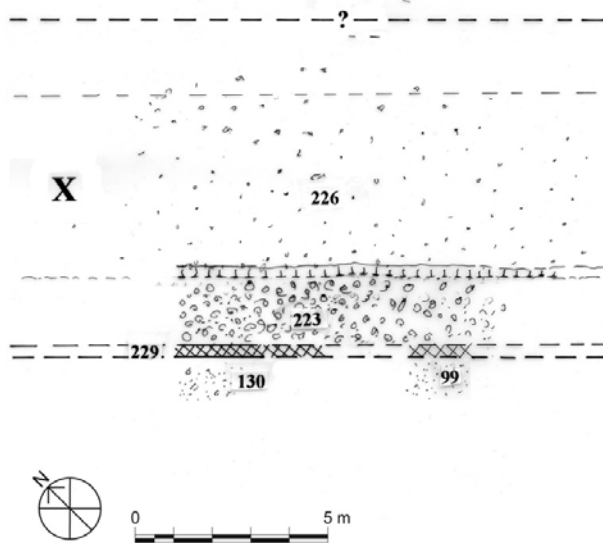
Fig. 6. Vicus. Trench X Plan., hase I

Phase I: early-mid 1st century AD (Fig.6)

Pure natural whitish-grey beach sand was reached 2 metres below the modern ground level. The earliest occupation on the site was represented by thick deposits of discoloured brown sand (X227,226), containing flecks of charcoal and a scatter of pottery, animal bone, oyster- and other shells. The pottery is consistently of mid-late Augustan date (ca. 10 BC-AD 10). N pavement or sidewalk; its level corresponds to a trace of an early building to the south, marked by a floor of lightly mortared sand (X130) associated with the foundations of a wall (X229). The street proper, if that is what it was, is represented by a series of sandy deposits (X224), capped with a harder surface (X219), made of nodules of mortar and tufa, pottery and shell. The pottery is of the Augustan-Tiberian period (AD 10-30).

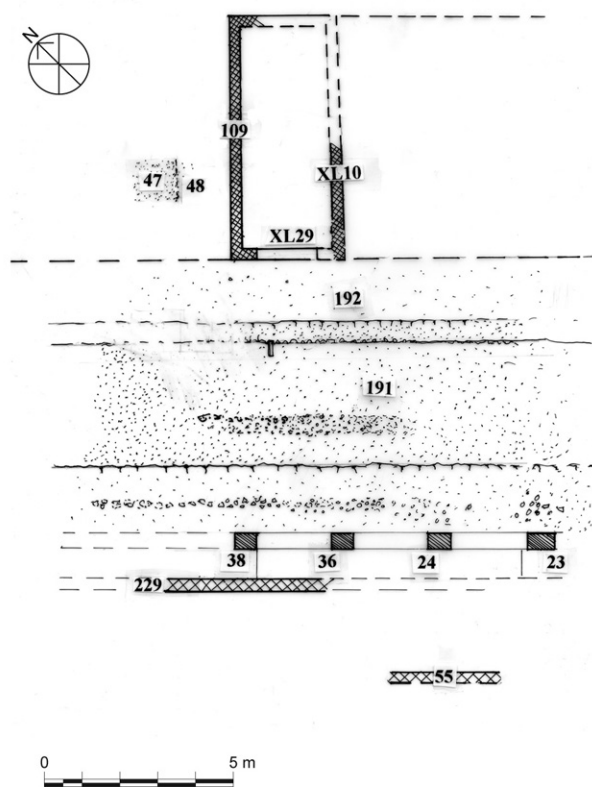
Fig. 7. Vicus. Trench X . Plan, Phase II.

Phase II: 2nd century AD (Fig.7)

The street surface X191 is made of concrete, 8 cms thick, circa 4 metres wide, with a harder band of stone nodules and cocciopesto incorporated into the southern half. The level slopes gently downwards from east to west. The sidewalks were left unsurfaced, presumably to act as soakaways, since the street had no other drains. The period of construction is difficult to determine precisely on the basis of the tiny fragments of coarse pottery and other material mixed in with the concrete (they could be of 1st or 2nd century AD), but it must have been broadly contemporary with new buildings on either side of the street, whose floors respected the same level. On the north side, the wall XL29 (subsequently replaced by wall X72 when the street front was rebuilt in phase 3) is reduced to the top of its foundations and of unknown thickness, but still preserves one of the travertine blocks which marked one jamb of a door to the street. The levels associated with its construction contain pottery from the second half of the 2nd century AD. The associated walls X 109 and XL 10, which were retained in the later phases of the building, are 30 cms thick and faced with brick and irregular reticulate. The building probably constituted a row of shops, one storey high. On the south side of the street, a portico with piers of brick (possibly vittatum mixtum)-faced concrete (X23,24, 36, 38), was built parallel to wall X229, covering about half the width of the earlier sidewalk. It lost its original internal floor level in the final phase (see below) but the pier-

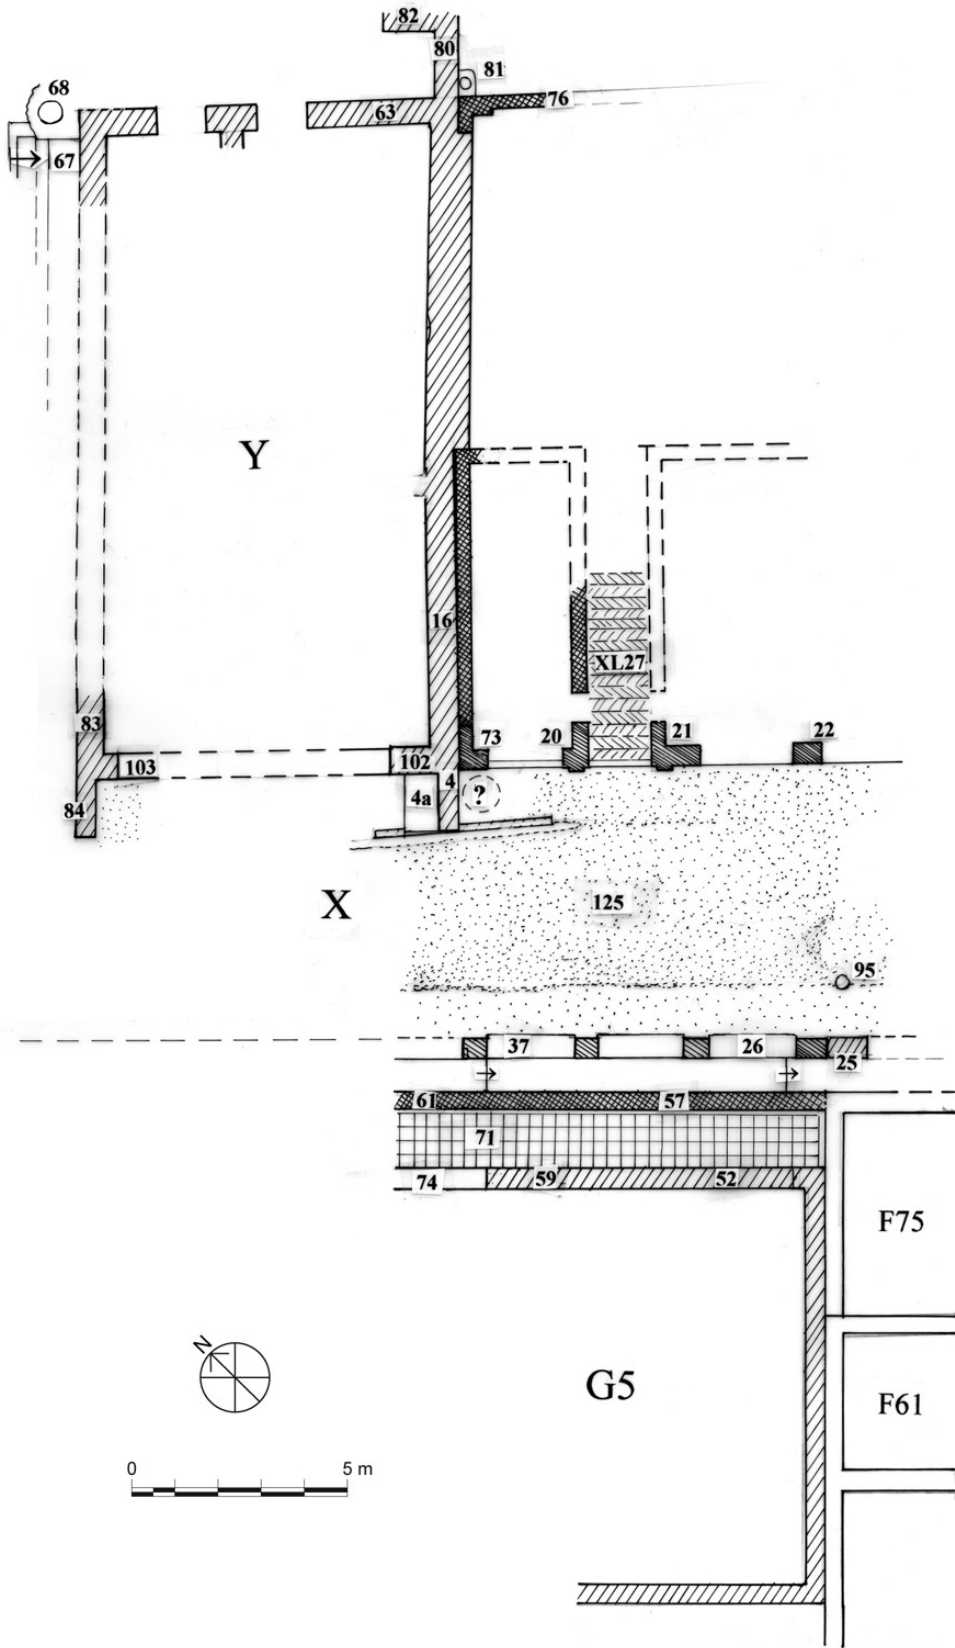
Fig. 8. Vicus. Plan, phase III

Phase III: 3rd-early 4th century AD (Fig.8)

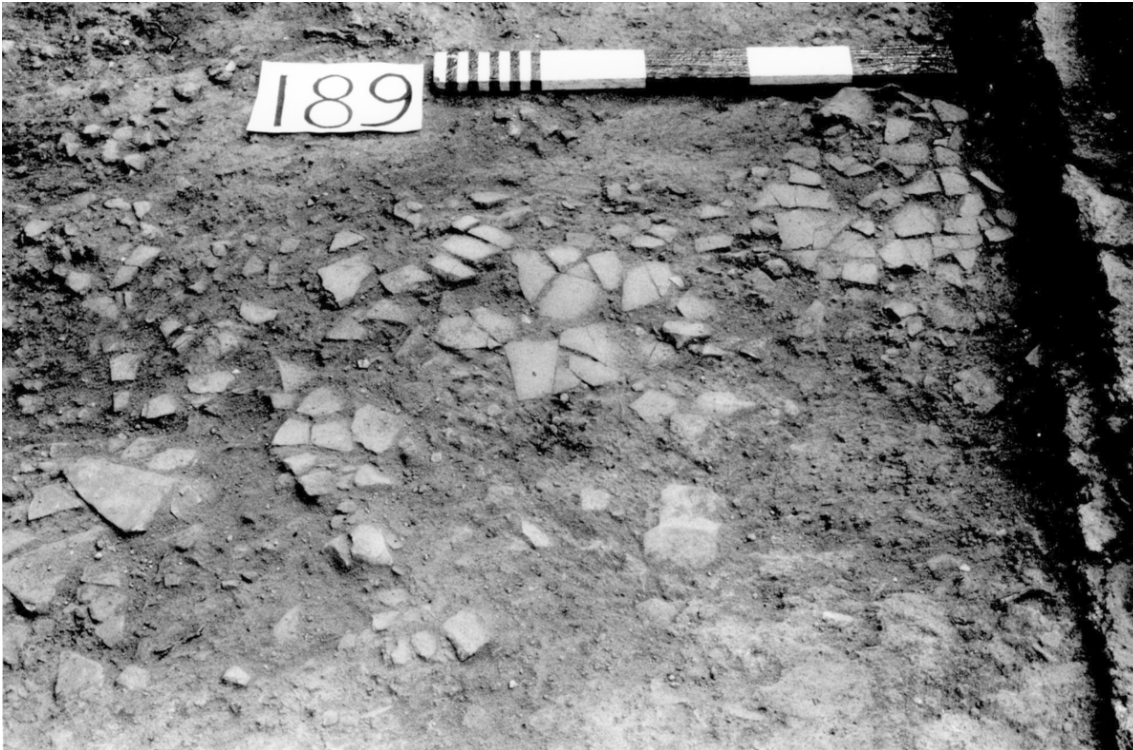
Fig. 9 Vicus. Trench X, detail of street surface in cocciopesto (X189)

The first concrete surfacing on the street (X 191) was evidently not very durable and was soon followed by X 189, entirely of *cocciopesto* (Fig. 9), containing pottery of the early-mid 2nd century AD. This too, after several large patchings in concrete, was levelled up with a layer of sand (containing fragments of brick and marble and pottery of the first half of the 2nd century AD) and replaced with a new surface of concrete (X 184). The margins, still unsurfaced, accumulated deposits of soil and other debris, those on the south side in front of portico X5 (X145, X 139) more consolidated and stratified than those on the north (X183). After further patchings, especially along the edges, which became worn as the run-off of rainwater formed gulleys, the roadway was metalled again, in *cocciopesto* mixed with small tufa rubble (X174), and gully channels (X 173), and, eventually, at least parts of the northern sidewalks were metalled too (X 175). More re-surfacings of the road (X 162/ X 158) and sidewalks (X 160, X 164) brought the general level up another 10 cms.

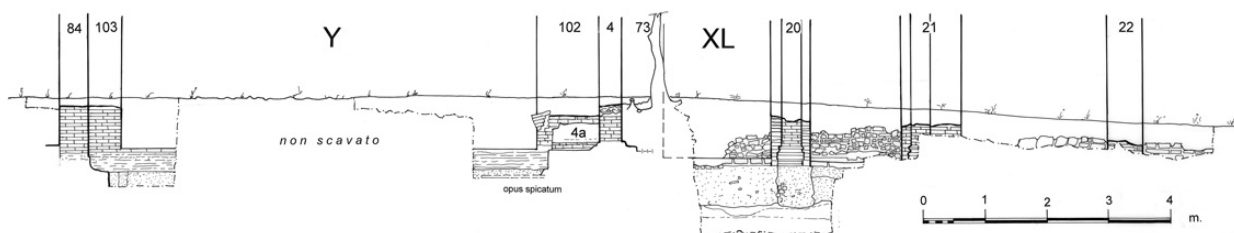
Fig 10a. Vicus. Trench X..Internal elevation of buildings on north side of street B

At that point the building on the north side of the street was remodelled, moving its street front a metre forward (wall X72, see elevation Fig. 10a), with wide shop doors to either side of a more elegant portal, framed with brick pilasters (Fig. 11). The packing under the floor of the new extension (XL26) contained pottery of the early 3rd

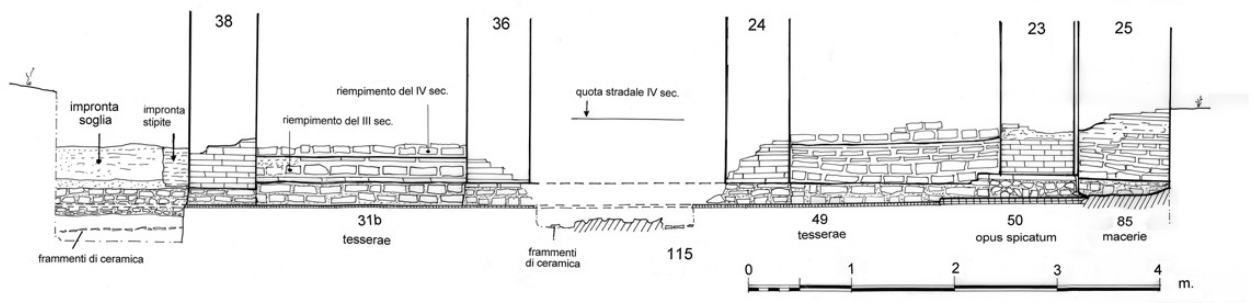
Fig. 10b. Vicus trench X. Elevation of buildings on south side of street B

footings step down in level from east to west (Fig. 10b), with a drop of 10 cms between X 23 and X24, and another of 10 cms between X36 and X38,, and we may suppose that the missing floor level within the portico stepped down in like fashion, reflecting the slope of the street in the same direction.

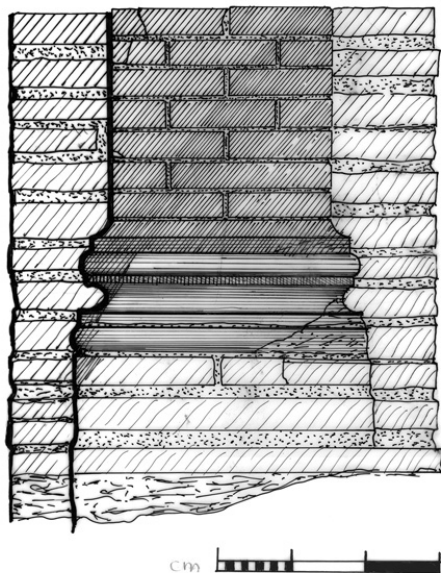
Fig.11 Vicus trench X Pilaster of portal

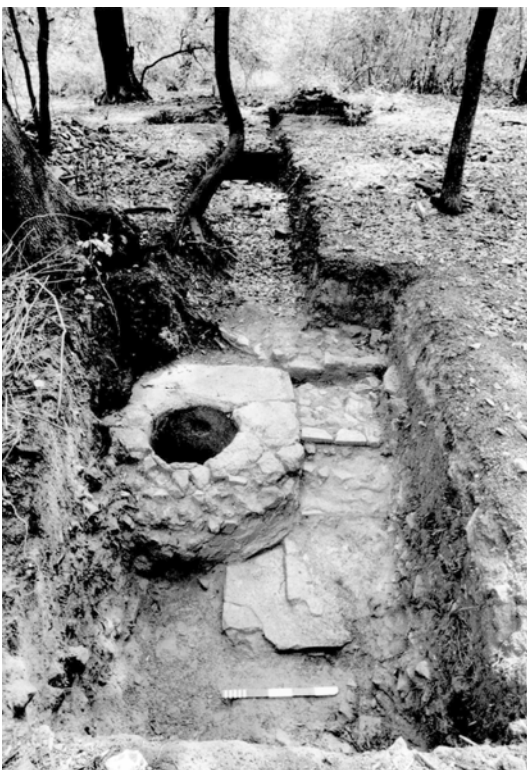
Fig. 12. Vicus. Building Y well-or cistern head on the outside of the NW corner of the building

freestanding, perhaps facing a street. The outer walls were very solidly built, 60 cms thick (on the eastern side widening in places to over 1.00 m) faced in opus vittatum with brick quoins, and are preserved to a height of about 1.40 m. At the NW corner is a well or cistern head (Y68), beside some steps (Y67, which may have continued along the full length of this side of the building); at the NE corner there is a large downpipe (Y81), presumably for rainwater from the roof. There were two small doors on the north side, both 1.18 wide, placed to either side of an internal wall off centre with respect to the longer axis of the structure. A similar asymmetry is found in the construction of the south side, where two narrower walls (XF 84 and X 4) prolonged the structure a further 1.40 metres, extending over the sidewalk to the edge of street B, perhaps to form a porch. The returns beside two openings in the wall behind the extension are of unequal length, and the larger space in the angle at the eastern end accommodates a large rectangular mass of concrete, faced with brick (X 4a). The sills of the openings on the south side are distinctly higher than those of the adjacent shop to the east. Soundings (XA and YA) on the inside of the building, however, found no floor surface, only a half a metre of hard-packed brick and concrete rubble collapse (XA 44/ YA58), containing quantities of coloured marble and pottery of the mid 3rd century AD, under which there was a black ashy layer, with pottery of the late 2nd/early 3rd century AD, directly on top of a cocciopesto pavement, whose level corresponds to phase II (X 191-189) in the street. The walls of building Y were constructed from that lower level, their deep foundations being cut through the black

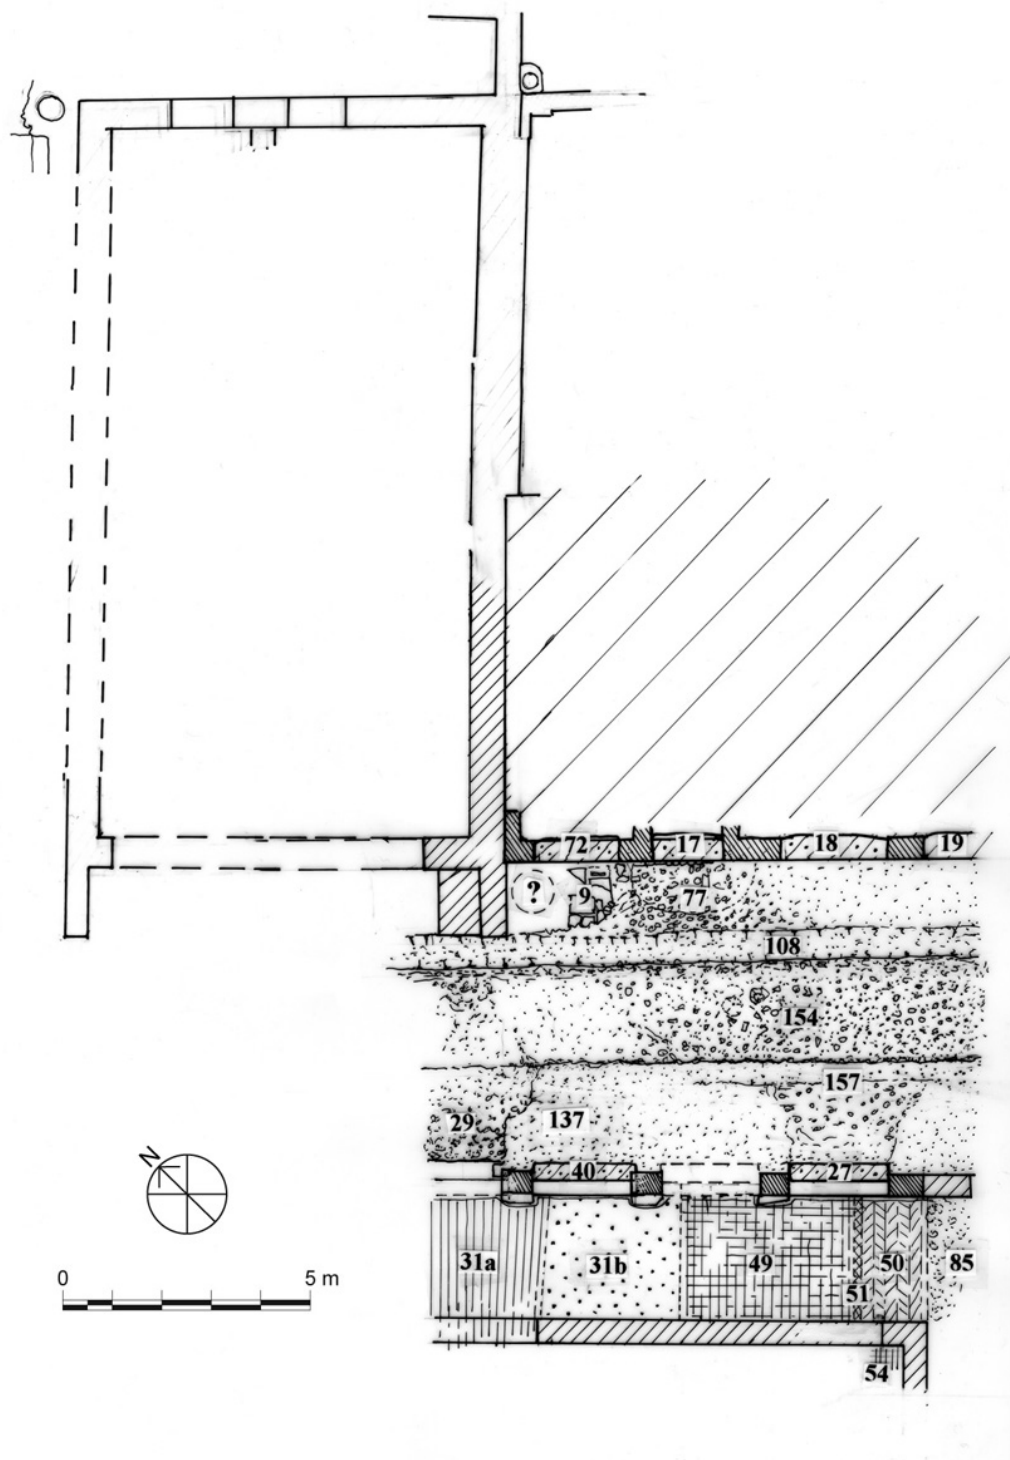
Fig. 13. Vicus. Trench X. Plan, phase IV

Phase IV: late 4th century -beginning of 5th century AD (Fig. 13)

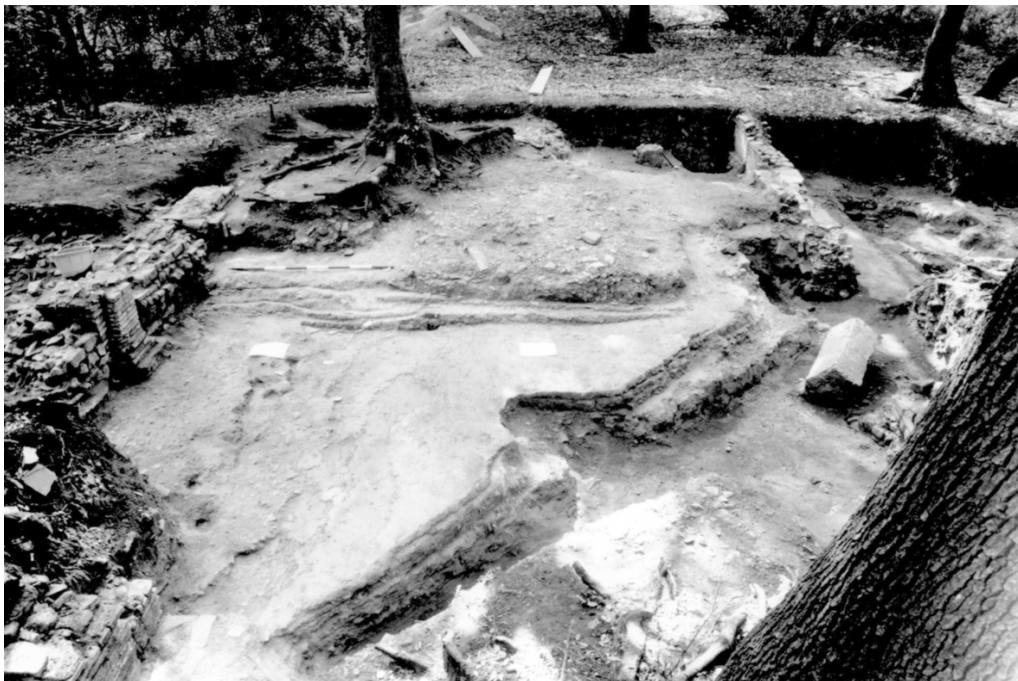
Fig. 14 Vicus. Trench X. View from west along street B. At the top, the final street level (X8). In the foreground the series of cocciopesto surfacings, cut by the diagonal trench (X28).

The latest street level lies only 10-20 cms below the topsoil (Fig. 14), a thick band of mortared rubble (tufa, limestone, tile and brick) on the same line as its predecessors but only 2 metres wide, with a shallow gutter between it and a raised sidewalk of equal width on either side. The road bed contained pottery and coins of the mid 4th century AD and the final deposits associated with it and the rest of trench X, and the area of building Y, consisted mainly of huge quantities of broken amphorae, with an admixture of pottery, glass and coins of the 3rd and 4th centuries, but nothing later than about AD 400.

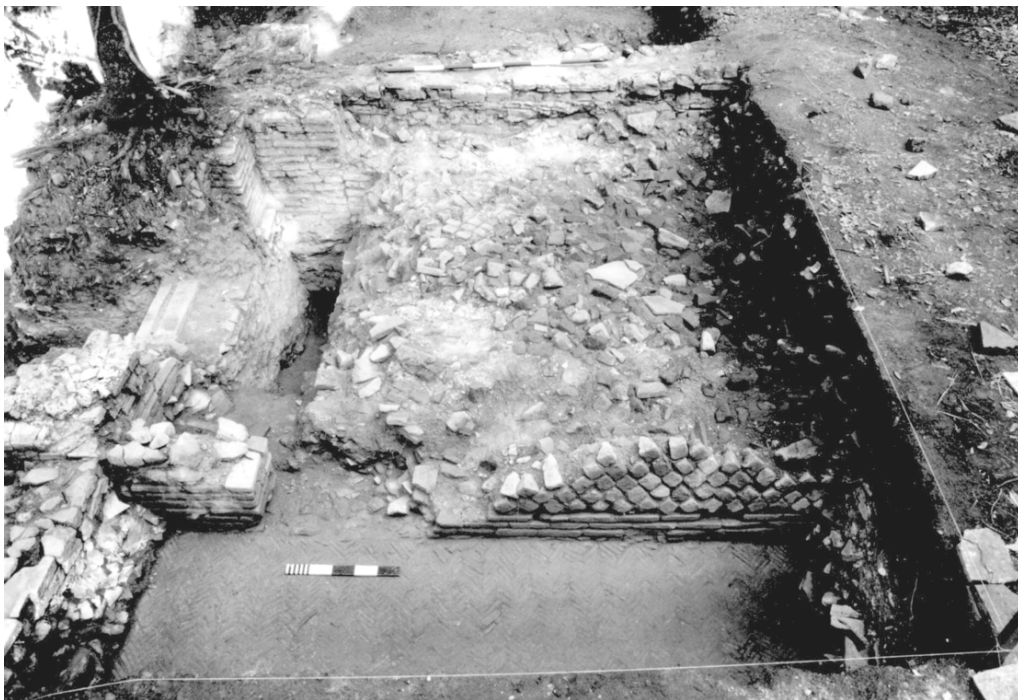
Fig. 15 Vicus. Trench XL, view from east. In the foreground the corridor paved with opus spicatum (XL27), its outer door blocked at the left. In the distance the collapse of the western wall of the taberna.

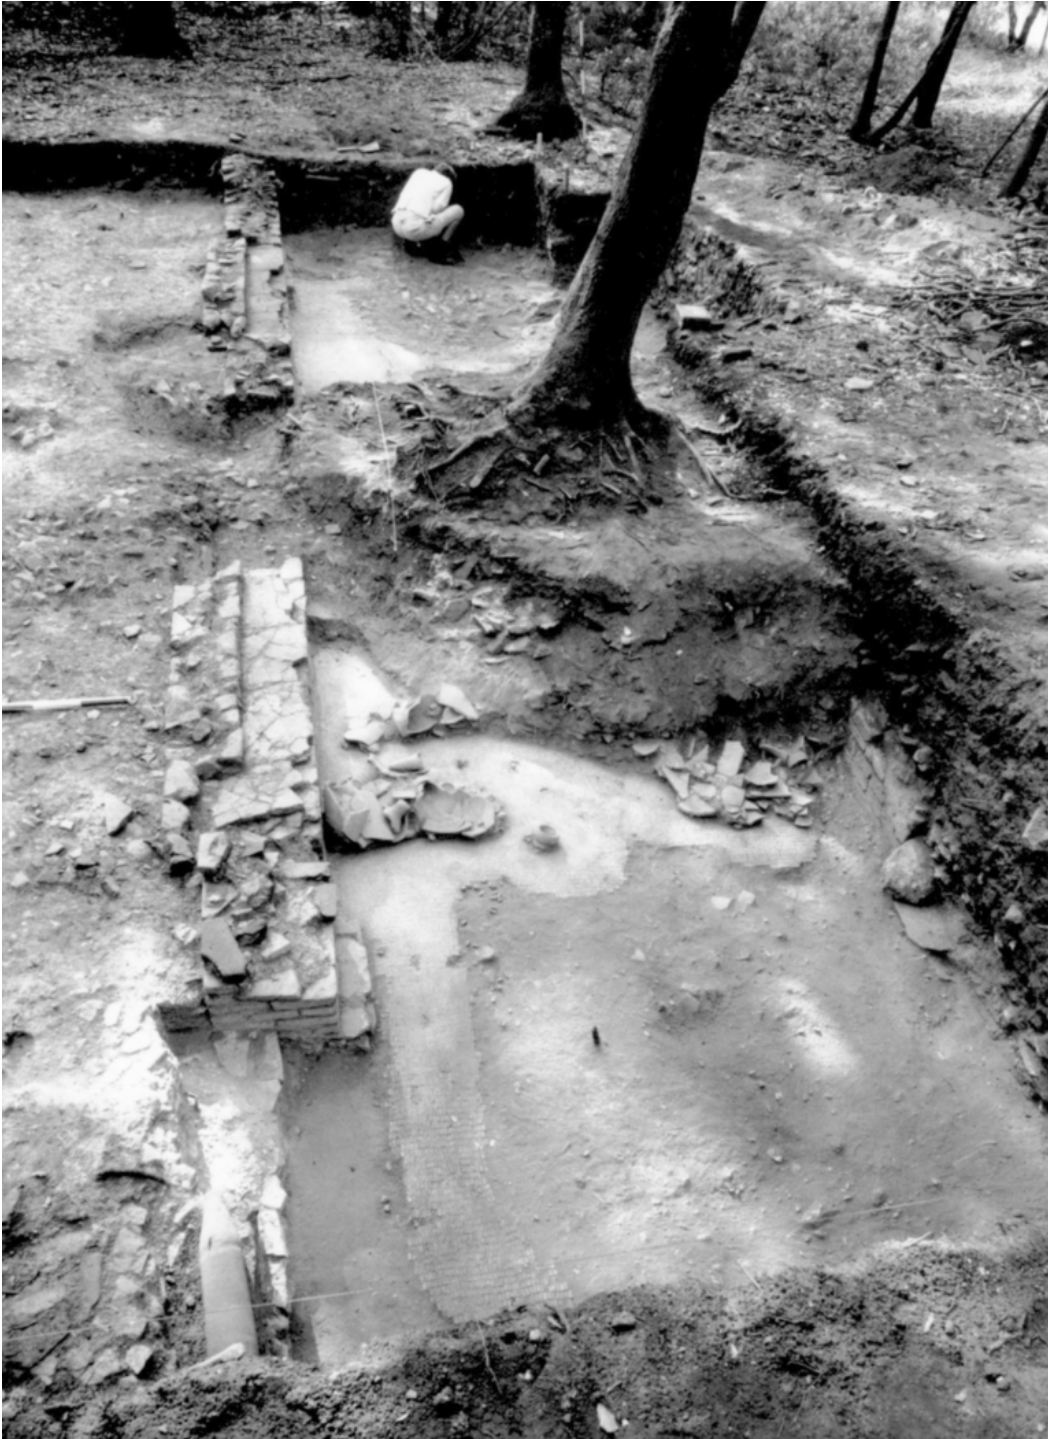
Fig. 16. Vicus. Trench X. View from west along the portico and rooms on the south side of street B, with the remains of lower level paving of phase IV bearing piles of crushed amphorae and lamps

floor (X31b), and the reason for its relatively good state of preservation compared with other parts, were piles of crushed amphorae and pottery lamps (Fig. 16). Over the whole area there then came thick deposits of (windblown?) sand, mixed with 4th century pottery and coins, and an Ionic capital which may have come from the peristyle G1. Other strange things were happening by this stage. A complete amphora of 'spatheion' type (X30), its neck connected to the foot of another late amphora (X32), was laid across the doorway to the west of pier X 38, perhaps taking the place of an earlier, now robbed-out threshold block. Generally, the lack of building materials in the destruction levels which cover the whole area (X 8, 6, 2, 1) is striking and argues for fairly systematic dismantlement and removal of all usable items. All the tops of the walls are reduced to about the same level, on a par with the uppermost level in the street. It is possible that the process of demolition and despoliation was already far advanced during in the final phases of occupation.

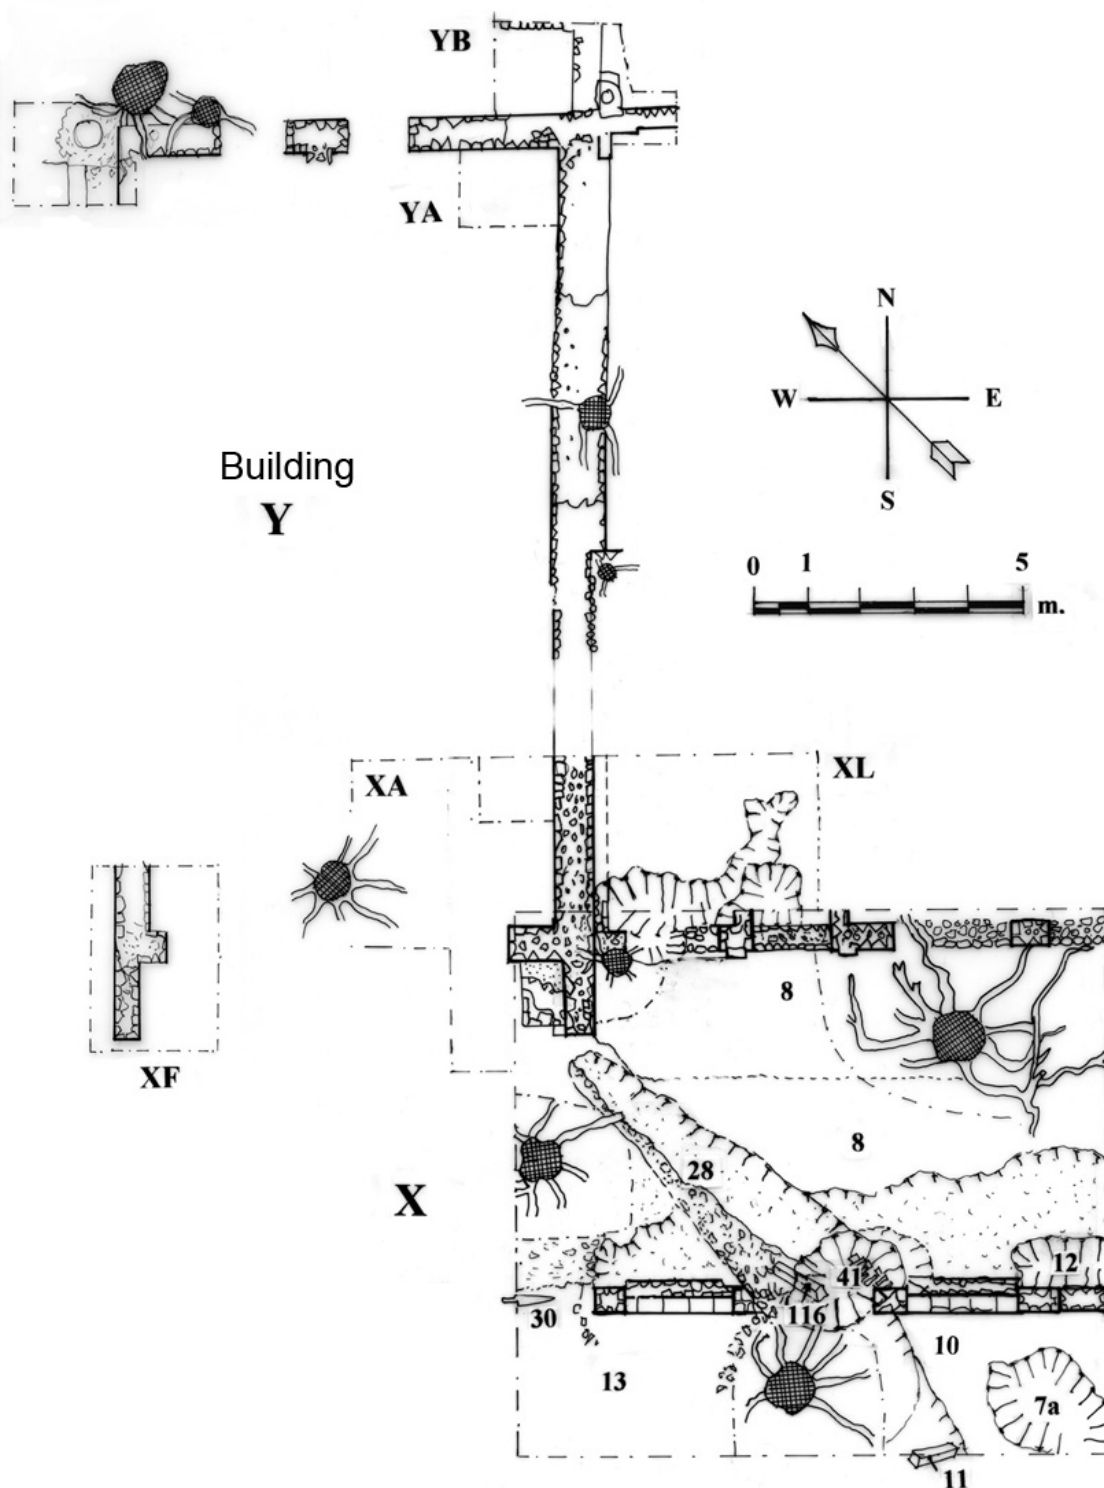
Fig. 17. Vicus. Trench X and building Y. Ohase V Later (post-Roman?) features

Phase V. Later (post-Roman?) features
(Fig. 17)

As noted above, in addition to four pits which had disturbed the ground to various depths, the excavation of the main trench X was complicated by a deep cutting (X28), which started near the foot of a small tree on the north side and ran in a fairly straight diagonal line across the trench, under the roots of larger tree, and off to the south (Fig.17). Broadly V-shaped in section, it had been cut in steps through all the concrete

surfaces in the street and through portico X 5, partly destroying pier X 36 and reducing whatever previously filled the space between it and pier X23 to a trace of a foundation (X 115). In its depths were two loose travertine blocks (X 116 and X 11), perhaps displaced from the walls beside which they were found. The date and purpose of the furrow are not clear. The most that can be said at present is that it predates the large pit beside pier X 23 and its fill consisted of silt and fine debris with an upper core of rubble, which may signify that the edges were heightened by walling. The fill contained pottery of every period from the 1st to the 4th century AD. It is probably later than the 4th century street level, through which it runs, but could be associated with the final destruction levels, since no post-Roman pottery or other indications of later occupation have been found in this part of the Vicus (though a short-lived medieval settlement has been identified in zone A). An answer to the question of its function may lie under the small tree at its northern end. Unfortunately the tree could not be removed, and thus had to be left with an island of soil round its roots, but a patch of paving at a high level (X9) gave the impression of being arranged around the point occupied by the tree - and the impression was repeated at various levels as the excavation descended around it. Very possibly the tree is rooted in a well or cistern head (cf those at the NW and NE corner of building Y, see above) and thus the cutting may have been made to carry a water pipe, or channel, or simply a drain, or it may have been made in order to rob some such feature, or to accommodate some industrial/agricultural activity which required water or a solid channel.

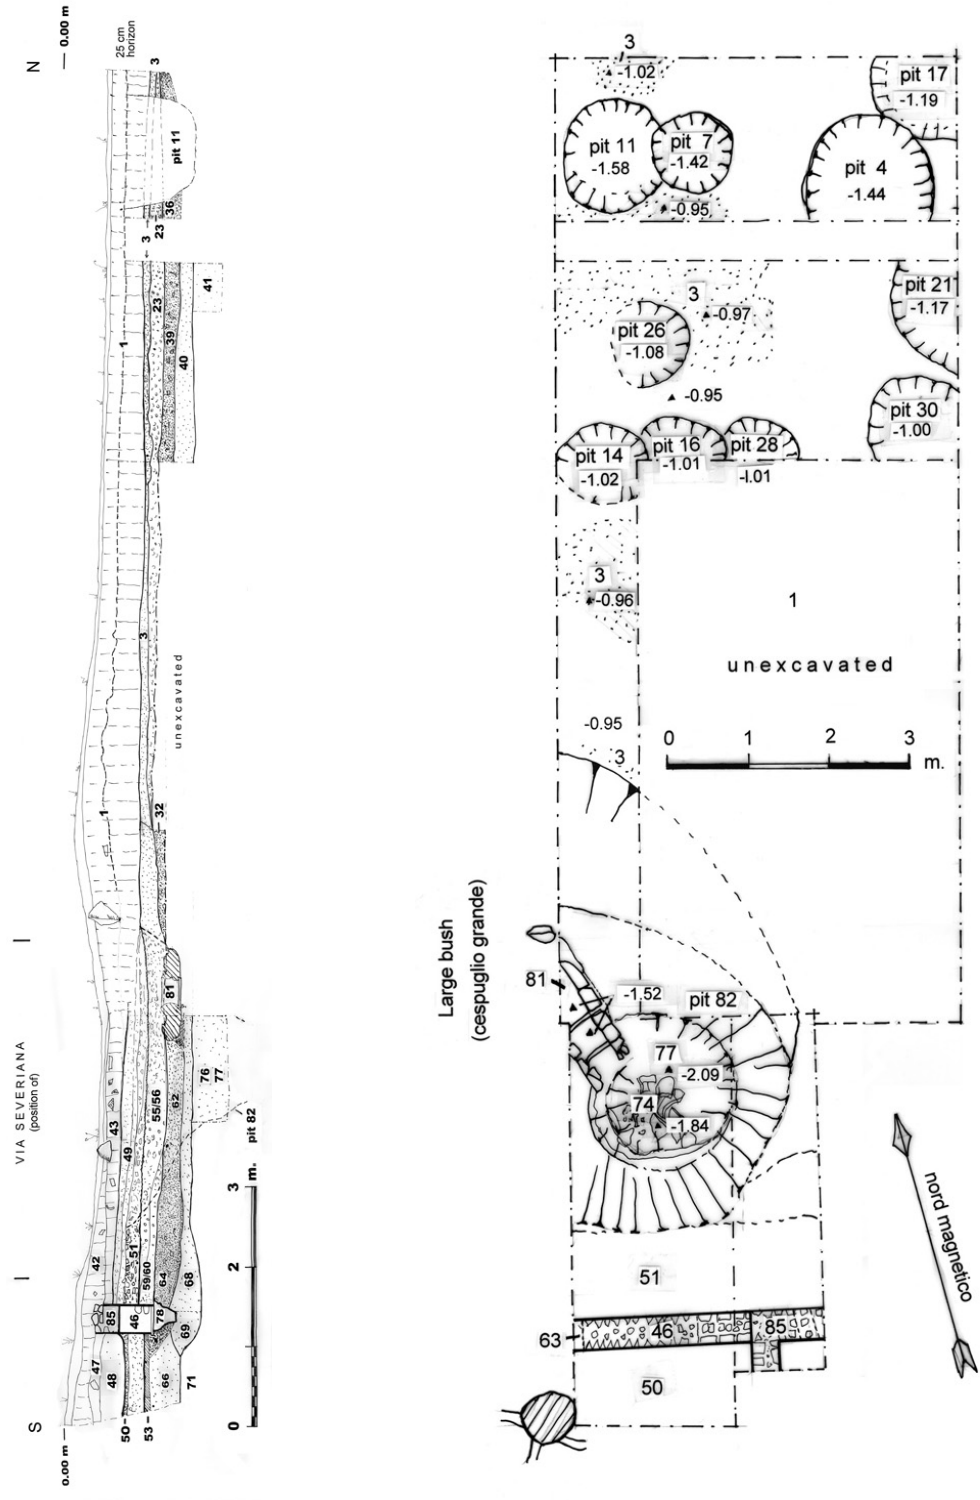
Fig. 18-19 Vicus. Trench SA Plan and section

The trench measured 5 x 16 metres, laid out so as to take in both sides of the roadway and extended a further 12 metres inland. Having cleaned the surface in the area of the road bed, it was clear that none of its basalt blocks remained in situ and that the scatter of basalt flakes from its destruction spread at least 3 metres inland, accompanied by considerable signs of disturbance (Fig. 20). Consequently, it was decided to excavate the far end of the trench first, and in 1996 an area 5 x 5 m (from 7 to 12 metres away from the road), was excavated in two spits (Fig. 21). There the grass and asphodel were growing on c. 50 cms of dark brown, almost black sandy loam (SA1), containing a scatter of fragments of amphorae and pottery (of mixed 1st-2nd century date), glass, metal (iron and bronze), and a coin of Constantius II (AD 348-360). Perhaps the product of agricultural activity in the area in medieval or early modern times, the earth is much disturbed by root action, small animal burrows and other intrusions, and in the section excavated in detail (9-12 metres inland from the road) was also difficult to disentangle from the upper levels of a series of sub-circular, oval or oblong pits (4, 7, 11, 14, 16, 17, 21, 26, 28, 30). A few of these were traceable in at least partial outline from a depth of about 25 cms below the modern surface; others were only clearly definable in their lower levels, where they had cut into a compacted, uneven horizon of pale yellowish sand SA3 (Fig. 18), but although the 25 cms horizon coincides fairly closely with the level of

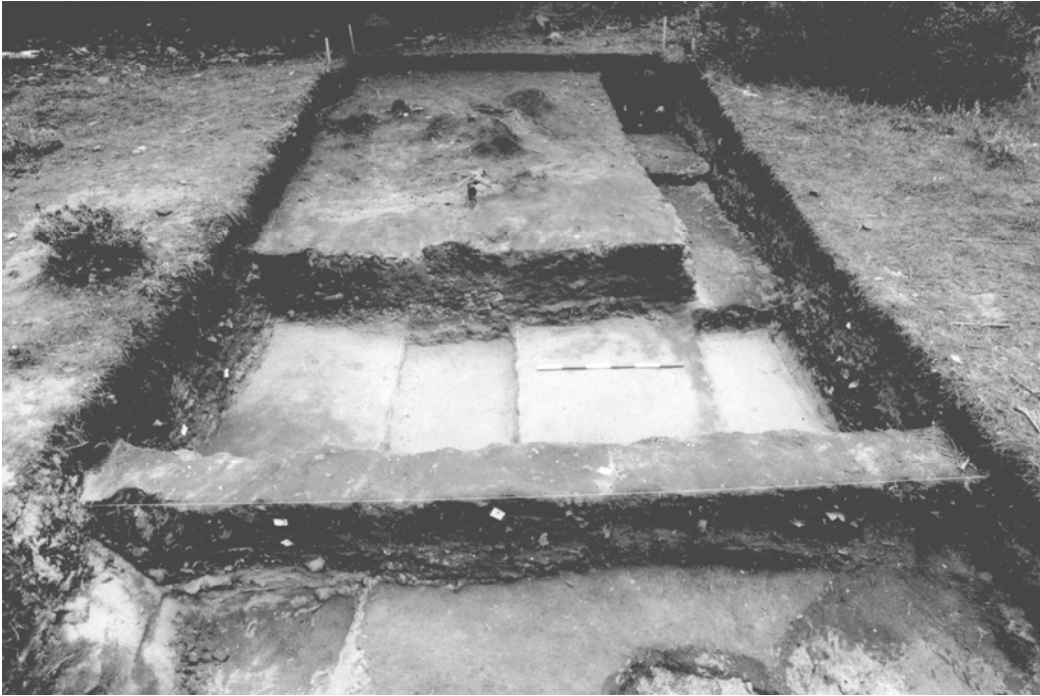
Fig. 22 Vicus. Trench SA. View from north at the end of the excavations in 1996, showing the three lower horizons (SA 40, 39, 36 etc.)

Sealed beneath the surviving areas of SA 3 was a more coherent stratigraphy, comprising three main horizons (Fig. 22). On top of clean white natural sand, which lay at an even depth of about 1.10 m. below the modern ground surface, first came some 25 cms of discoloured light/medium brown sand (SA40), containing some fragments of Augustan and Tiberian pottery: similar to the earliest deposits found in trench X on the main site (see above Phase I, X227-6). No individual pits of the sort excavated in trench S in 1985 (*Castelporziano I*, p.70 and 68 fig.11a and c) were found;
