Report on excavations at the imperial vicus 1995-1998*

by Amanda Claridge

The purpose of the excavations

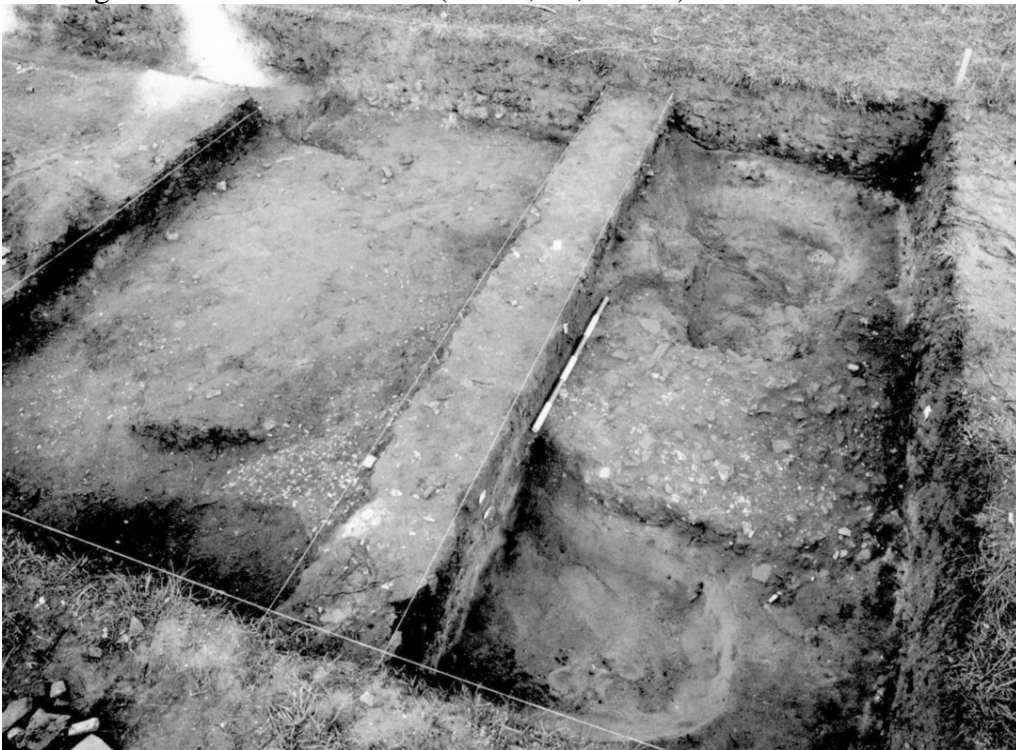
Fig. 23 . Vicus. Trench SA. View from east, showing layer SA 23, composed of shells and assorted pottery and other materials

Then came an undulating spread of occupation material (SA23, Fig. 23), c. 10 cms thick, characterised by quantities of small marine shells (concentrated in patches) and fragments of amphorae and other ceramics, with an admixture of various small bronze objects, including two coins, and animal bone (and a human lower mandible). The impression is of rubbish being scattered over an open area rather than buried in pits. The pottery from SA23 (over 2300 sherds) was all of 1st century AD date, predominantly c. AD 40-55; one of the coins is Augustan, the other illegible. Its successor, the sandy layer SA 3, was hardpacked but powdery, containing flecks of charcoal and small fragments of pottery (mostly of the mid 1st century AD in so far as they can be dated). The layer varied from c. 10 to 20 cms thick, in some areas consisting of irregular lumps, in others forming ridges looking rather like small dunes, which may signify that it lay exposed to the elements for some period of time. Traced along the western margin of the trench, it petered out well before the road (Fig. 19), perhaps artificially truncated by building operations associated with the drain in the far southern corner (SA 34/81), which had also invaded the earlier dumps (SA39).

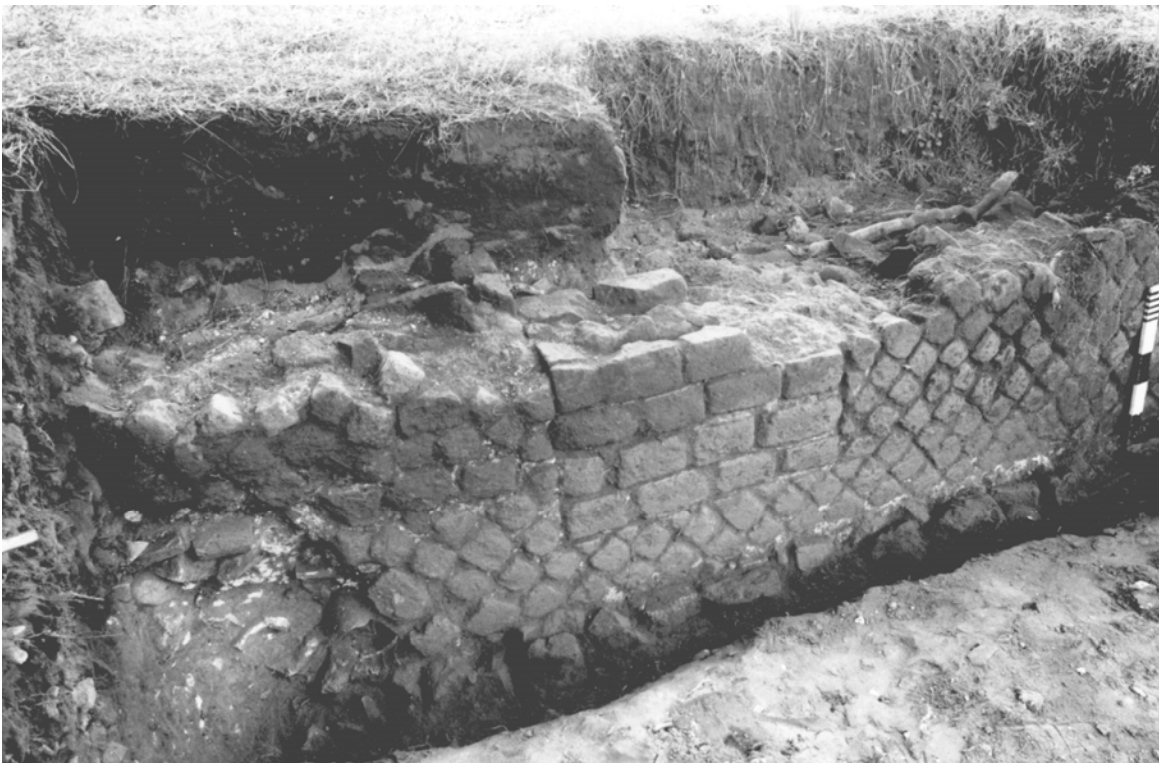
Fig. 27 . Vicus Trench SA. North face of reticulare walling (SA 46) on south side of Via Severiana. On the left, its rebuilding (SA85) and a hole (SA83) containing two drainpipes.

The level coincides with a rebuilding of the eastern section of the wall (SA 85/86). The foundations of the original wall, however, lie 50 cms lower, cut through deep black, burnt deposits (SA 64/62-61) which closely resemble the mid-late 1st century dumps further inland (SA36-39). The building has two levels of paving inside (SA 53 and 50), the initial one (SA53) consisting of crushed wallplaster and pottery of uncertain date. The second level, in a hard cocciopesto which curved up the adjacent wall in the manner of waterproofing, had pottery of the later 1st century AD in its makeup (SA52); a hole was made through the wall to take a drain pipe (SA63) out to the road. The level corresponds on the outside with a very hard rubble packing, mixed with large fragments of amphora (SA 51), sloping downwards, away from the wall. This may have constituted the road surface, or a sort of hard edge between
